Miami Conservancy District

Pipe Inspection Manual

For Pipes Through or Adjacent to MCD Infrastructure

April 2024

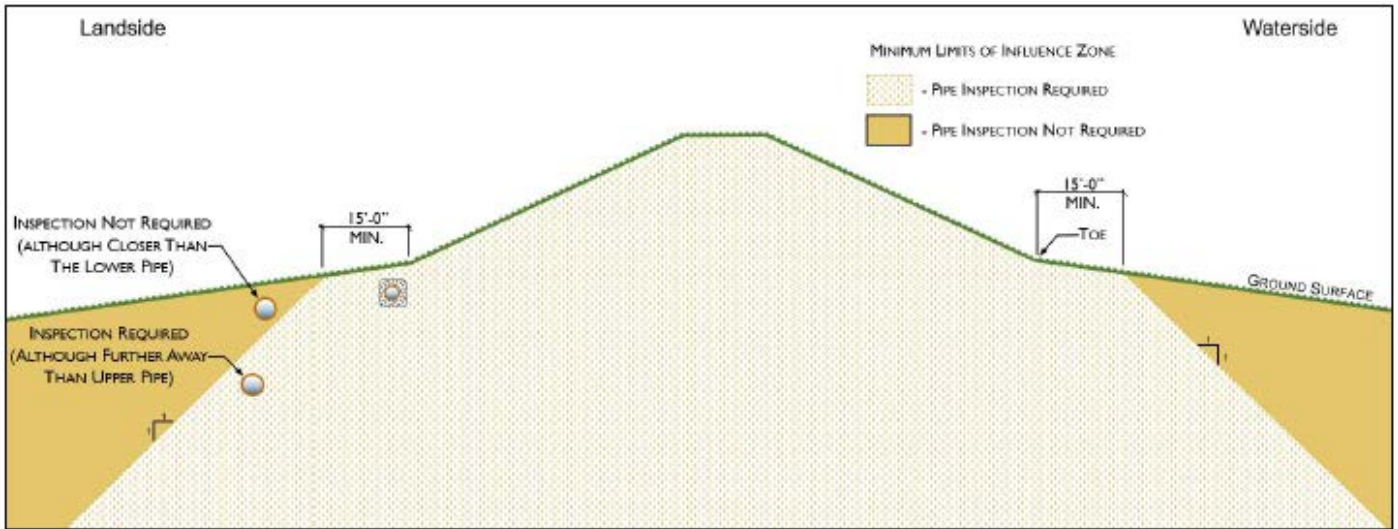
Pipes running adjacent to flood protection infrastructure that are within 15 feet horizontally of the levee toe or floodwall, within eight feet of the floodwall foundation or toe drain, or below a 1H:1V slope from that point, require inspection. See Figure 4 for an example of a pipe running adjacent to a levee.

Figure 4: Pipes running adjacent to a levee example
USACE EM 110-2-2902 Figure 6-7

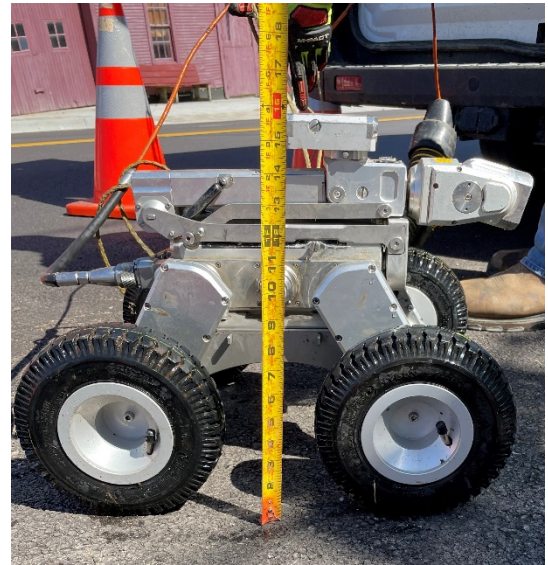
Figure 7: CCTV wheeled camera

- Travel speed: Maximum travel speed through the pipe not exceeding 25 feet per minute.
 - Still Images: Ability to take still images in .jpg or .png format of all significant defects observed during the inspection.

- 360-degree Joint Views: Ability to stop traversing and record a 360-degree view of each joint.
 - Defect Recording: Ability to stop traversing if any defects are suspected and record a detailed video inspection.
