THE MIAMICA CONSERVANCA EULLETIN

NOVEMBER, 1921

MIAMI CONSERVANCY BULLETIN

PUBLISHED BY THE MIAMI CONSERVANCY DISTRICT DAYTON, OHIO

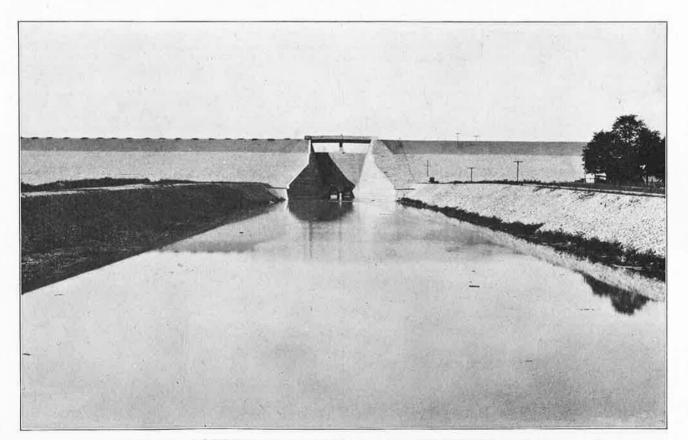
FIG. 329.—LOCKINGTON DAM COMPLETED, SEPTEMBER 28, 1921.

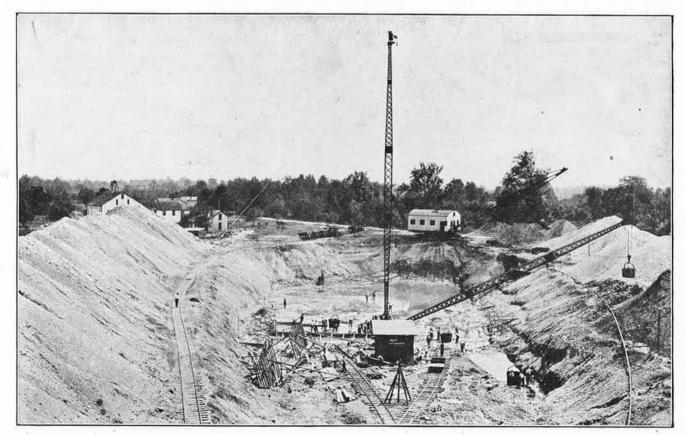
FIG. 332.—LOCKINGTON OUTLET STRUCTURE AUGUST 12, 1918.

The overburden has been removed by the dragline in the background. The derrick is removing loose rock preparatory to placing concrete. The first forms are being placed in position.

The conditions for building the outlet structure were good. Bed rock on which to place the concrete, occurs to the east of Loramie Creek, only a few feet below the elevation of the creek bed. The first job, therefore, was to strip off the gravel and earth that lay on top of the rock, clean off loose rock, and prepare the foundation. The stripping operations were performed with a Lidgerwood Class K dragline; the rock was shaken up by blasting, loaded into buckets, and hoisted out with a derrick (see Fig. 332). The gravel taken out of the excavation proved to be of good quality, suitable for concrete, and was piled to one side for use later, as can be seen in both Fig. 332 and Fig. 334. Such good progress was made that the first concrete was poured on August 10, 1918. Englewood was engaged in the same operation, and progressed at about the same speed. The two jobs had a spirited race to place the first batch of concrete, reached the tape neck and neck, and both claimed a victory.

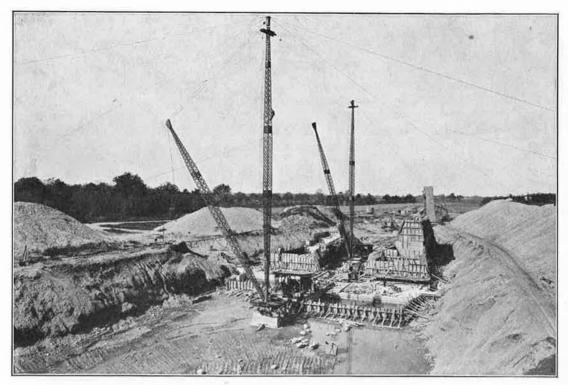
FIG. 334.—THE LOCKINGTON OUTLET STRUCTURE AUGUST 14, 1918.

This picture was taken from the roof of the drag-line and is looking upstream. The two derricks in the middle of the picture handled the forms, and hoisted the concrete buckets to the forms. The sand and gravel was washed and screened and the concrete mixed in the washing plant seen in the background. The concrete was run from the mixer into bottom dump buckets set on narrow gauge cars and hauled by a gasoline locomotive to a point where the buckets could be reached by the derricks. The hydraulic jump was built in the pit shown in the foreground.

The gravel for the concrete was washed and screened, and the concrete mixed, in a Dull plant situated near the upstream end of the conduits. The concrete was transported from the mixer in bottom-dump buckets, by a train of narrow-gauge flat cars, drawn by a gasoline locomotive. Two guy derricks, 120 feet high, with booms 105 feet long, handled the concrete buckets from the cars to the forms, and shifted the movable forms. The walls were built in sections, as is seen in Fig. 334. Some grouting under pressure was necessary to seal seams in the rock underneath the concrete.

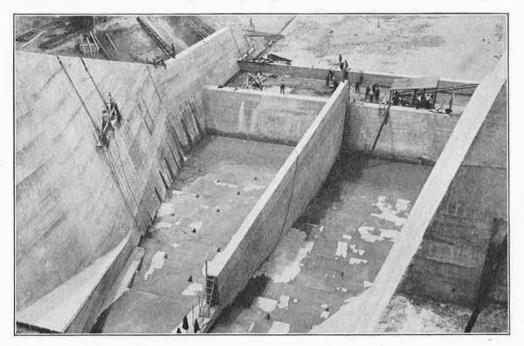
FIG. 336.—THE HYDRAULIC JUMP AT LOCKINGTON JUNE 11, 1919.

This picture was taken from the top of the wall the day water was turned through the outlet structure. The water coming from the conduits descends the stairway into the hydraulic jump pool which is divided into halves by the partition wall. The water then goes on over the first wall, into the stilling pool, then on over the second wall into the outlet channel. The standing wave occurs in front of the first wall. The proportions of the structure were determined after extensive experiments with models. The floods in the spring of 1920 and 1921 gave this struc-ture a good tryout. Pic-tures of the jump in action at Lockington were shown in the May, 1920, number of the Bulletin. A full description of the hydraulic jump was contained in the April, 1921, number.

The Lockington outlet structure is of the retaining-wall type, and is entirely of concrete. It forms a gigantic trough through the dam, from toe to toe and from top to bottom, its edges being coincident with the outlines of the dam. Its sides are formed by two massive retaining walls, passing entirely through the embankment at right angles to its center line, parallel to each other in the middle, and diverging at both ends to facilitate the entrance and exit of water. Its floor is of heavy concrete, laid on the bed rock. At the downstream end is the "hydraulic jump pool," a device to reduce the velocity of water. When the basin above is full, the waters will rush through the conduits at forty miles an hour. Such a stream at such a speed would prove disastrous to the channel below, and the energy must be used up before leaving the dam. The hydraulic jump, with its "stairsteps," "jump," and "pool," uses up energy when the water lifts itself up in the standing wave, and dissipates its fury in fighting with itself in the turmoil below, leaving the lower end quietly at a harmless speed. (Fig. 336.)

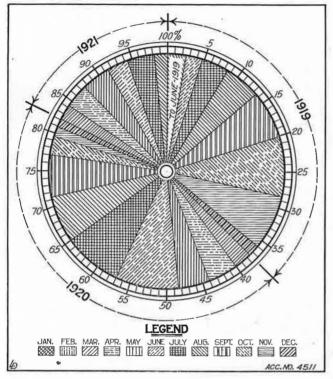
FIG. 337.—LOCKINGTON PROGRESS DIAGRAM. The placing of the earth embankment is shown in terms of the per cent of the total yardage placed each month.

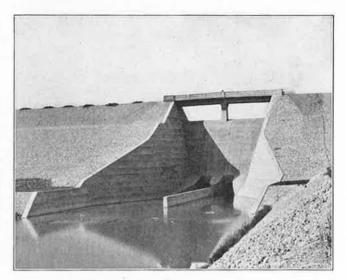
FIG. 342.—THE COMPLETED OUTLET STRUCTURE SEPTEMBER 28, 1921.

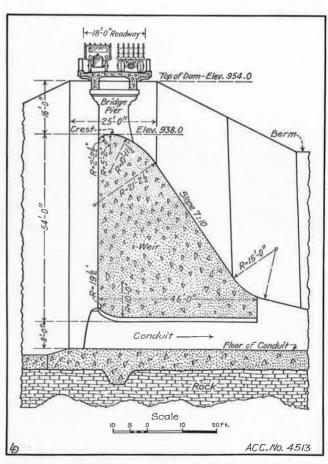
FIG. 343.—SECTION THROUGH WEIR AND BRIDGE.

In constructing the weir, steps were left in the curved face where the bridge pier was later placed. Thus all of the load of the pier and bridge is carried on the horizontal steps and no shearing stress is developed along the face of the weir.

Therefore this bridge is built on a vertical parabolic curve; that is, it has a hump in the middle. Besides this curve the girders themselves are one inch higher in the middle than at the ends. This is called camber in engineering terms and is put in to take care of deflection or sag in the girders.

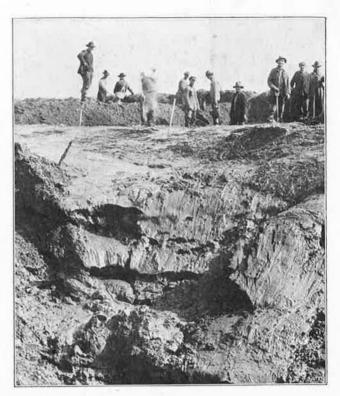
FIG. 345.—CORE EXPOSED AT ENGLEWOOD, OCTOBER 26, 1921.

The core resisted the rush of water extremely well. The face is standing nearly vertically and looks as if it had been cut with a great knife.

An unusual opportunity was afforded to study the condition of the core material, after it had been in place for some time. The upper edge of the wash exposed about 30 feet, in vertical depth, of the core. The material was so firm that it stood up in a vertical wall, almost as if it had been cut down with a great knife. See Fig. 345. It also resisted the rush of the water extremely well, and little of it was washed away. What did go, went in chunks, many of which did not break up much on their trip down the gully. Some of the lumps on top of the gravel debris at the foot of the gully measure over a cubic yard in size. It is very likely that several inches of very soft stuff on top, in the immediate vicinity of

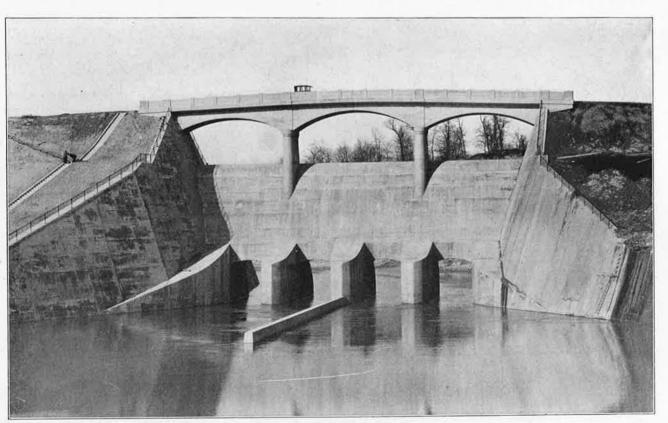
FIG. 346—TAYLORSVILLE OUTLET WORKS, MARCH 3, 1922.

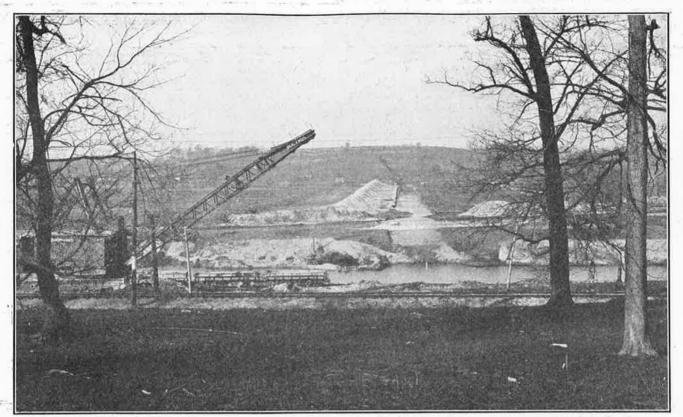
FIG. 347. LOOKING NORTHWESTERLY ALONG THE CENTER LINE OF THE HUFFMAN DAM SITE, DECEMBER 17, 1918.

The track in the foreground is the temporary line of the Ohio Electric; the temporary line of the Big Four is just below the hill. The water just over the hill is in the excavation for the outlet structure. The river channel can be seen just beyond. The ditch full of water running towards the distant hill is the cutoff trench along the center line of the dam.

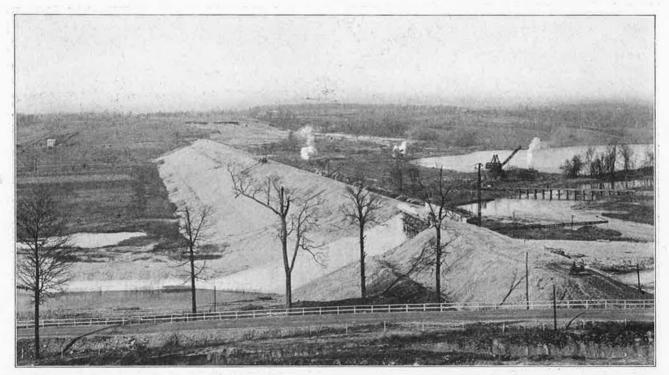
FIG. 348. THE COMPLETED HUFFMAN DAM ON JANUARY 6, 1922, LOOKING NORTHWESTERLY FROM THE EDGE OF THE BIG CUT.

This view was taken from a point higher up and farther downstream than the one from which the view just above was taken. The big cut is at the photographer's back. The cut at the lower edge carries the permanent location of the Ohio Electric. Then comes the relocated Springfield Pike, and then the part of the dam built by teams. The forms are still under the spillway bridge. The men on the hydraulic fill part of the dam are putting the finishing touches to the trimming. The river channel at the right has since been closed off, and a new one opened up.

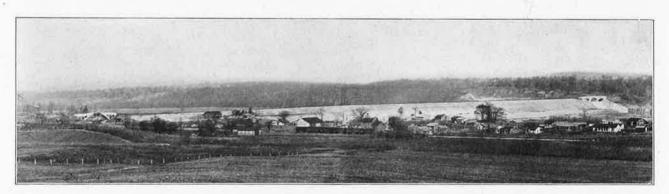
FIG. 349. TAYLORSVILLE DAM, MARCH 3, 1922.

View looking upstream. The dam is all complete, save for the guard rail along the road across the top of the embankment. The bridge at the left is the highway bridge carrying the National Road over the relocated B. and O. tracks. The bridge at the right is the spillway bridge shown on the frontispiece. The buildings in the foreground formed the construction village when work was in progress and are now being sold and removed.

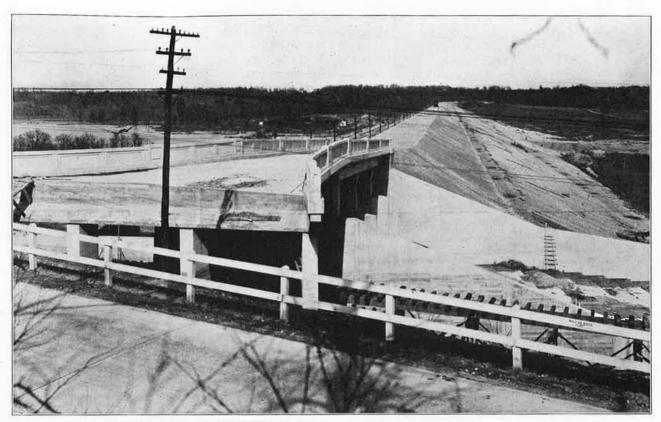
FIG. 350. ENGLEWOOD DAM, LOOKING EAST ALONG THE DOWNSTREAM FACE. MARCH 16, 1922. The spillway and bridge are in the foreground. A fill is yet to be made connecting it to the Covington Pike, shown in the left hand corner. The tracks of the Dayton, Covington and Piqua will be placed on a fill where the trestle is now, and will pass under the spillway bridge. The dam itself is all complete save for the guard rail along the road over the top. Considerable water was being stored in the basin when this picture was taken. The outlet from the conduits is behind the fill in the middle background, and at the extreme right of the picture. The fill is a part of a temporary spillway.

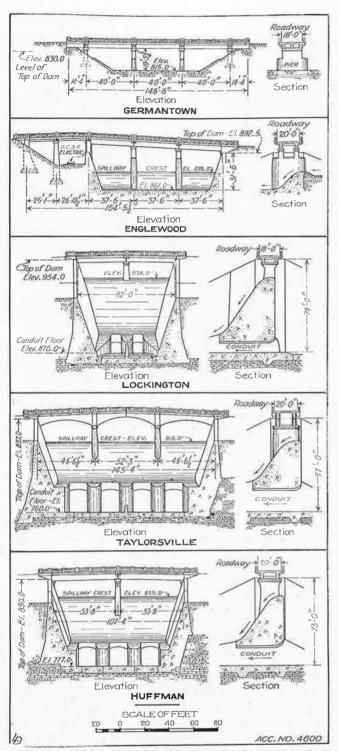
FIG. 351. COMPARISON OF THE FIVE SPILLWAY BRIDGES.

structures, while the abutments for the bridge at Englewood are the spillway walls of less height, but high enough to be a special problem in themselves. The Germantown bridge is situated unlike any of the other four. See figure 351. The requirements of flood protection imposed other limitations. The spillways are designed for a maximum water depth varying from 10 feet to 14 feet at the different dams. Three feet was decided upon as the minimum distance between the maximum water surface and the bottom of the bridges. Types of structures giving long clear openings to prevent possible clogging by drift, and to permit as large a discharge as possible, were also desirable. Permanence, safety, good appearance, and economy in cost were also necessary features.

Of the girder types, the most desirable would be a single span, reaching from wall to wall, and without piers in the waterway. However, the dead weight of the girders would have been so great, due to their great length, (80 to 144 feet), that a departure from conservative designs would have been necessary, and a field entered that is not covered by experimental data or practical experience. Such a departure from accepted engineering practice was not thought advisable in such vital structures as these. Therefore, the use of piers, placed on top of the spillway weirs, and spaced far enough apart to give a wide clear waterway, was decided upon (see figure 351) thus reducing the length of girders to within the sixty foot mark. The types of girder

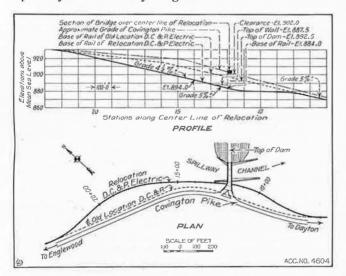
FIG. 353. THE ENGLEWOOD SPILLWAY AND BRIDGE AND THE D. C. & P. RELOCATION.

dam, close to the Dayton, Covington, and Piqua Traction, and the Covington Pike. By relocating about 1800 feet of the traction line and running it through a supplementary opening just west of the main structure, a grade crossing at the end of the spillway bridge was eliminated. The elevation of the highway above the top of the dam, and the necessity for clearance over the track resulted in the bridge being built on a 5 percent grade, instead of the usual parabolic curve. The closeness of the structure to the road, and the grades, necessitated a flared out floor on the west end to make a good connection with the pike. Figs. 353 and 350 show conditions. Because of the unequal length of the spans, the shallow beams over the traction and the odd shaped floor, it was impractical to use anything but the deck girder type of bridge.

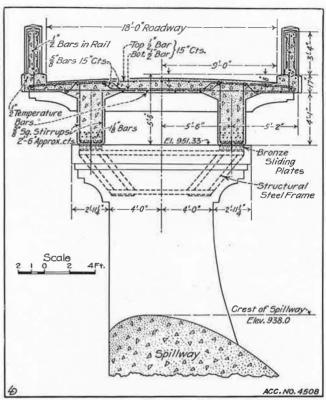
Fig. 354. CROSS SECTION OF THE LOCKINGTON SPILLWAY BRIDGE.

The advantages of the two girder type over the three girder type are quite interesting. Inspection of Fig. 354 will show that a shorter pier can be used under the two girders, with a consequent saving. Then, a pair of bronze expansion plates are saved, which is another economy. The form work for two girders is less than for three, as the framing for one girder is saved. It is an axiom of design that a floor carried on two supports is a simple structure, while one carried on three is a complex structure which cannot be accurately analyzed, and contains

Fig. 354 illustrates a typical girder as actually designed and built. It is shaped like a letter T. The load of the weight of the bridge, the passing truck, and the impact from the moving load, tends to bend the girder. This produces compression in the top of the girder, or the head of the T, which is resisted by the concrete itself, and produces tension in the bottom of the girder, which is resisted by the steel bars at the bottom of the stem of the T. The force which tends to bend the girder also tends to cause the particles of the concrete to slide upon each other, both in a vertical and horizontal direction. This latter tendency is called shear.

The floor slab is similar in all of the bridges. As shown in Fig. 354 the floor slab and curb overhang the girders which support them. This gives a simple span between the girders and two cantilever projections or brackets on the outside. The cantilever projection and the simple span balance each other, and therefore, the slab of the simple span need not be as thick and strong as would be necessary if the cantilever projections were not used. The simple span is designed as if the rear wheels of the 20 ton truck were distributed over 5 feet 9 inches in length, of the floor. The overhanging cantilever part of the floor is designed as if the same load were distributed over 2 feet in length of the floor.

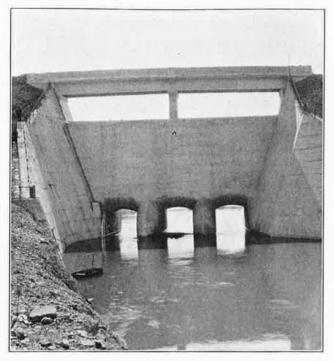
FIG. 355. HUFFMAN SPILLWAY AND BRIDGE, MARCH 22, 1922.

The view is from the basin side looking directly downstream. The long beak on the piers extending upstream is for the purpose of breaking up ice and debris. The expansion joint in the bridge can be seen just over the pier.

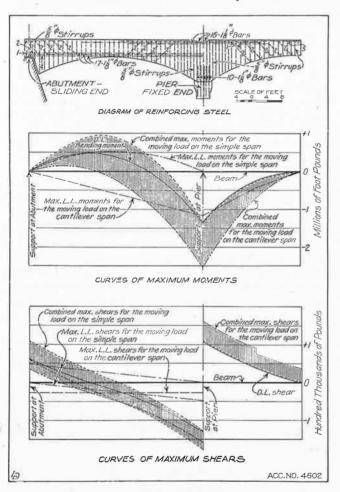
FIG 357. THE CANTILEVER GIRDER AT TAYLORSVILLE.

The lower diagrams were made by plotting the maximum bending moments and shears for each point on the girder, and drawing curves through them. The maximum moments and shears are produced by the dead load plus the live load in the worst position for the particular point being considered, plus the impact from the live load. Take away the live load and impact, and the moment and shear due to the dead load remains. The shaded areas represent the range in bending moments and shears between the dead load alone and the dead load plus the maximum live load and impact. The actual design is worked out from these diagrams, as explained in the text of the article. The influence of the diagrams on the location of the steel is especially well illustrated. It should be remembered that the design is a cut and try affair, and that a change in the dimensions of the bridge would change the dead load, and consequently the diagrams. The ones shown above are for the final design. Before they could be made, many preliminary diagrams were made and discarded.

Besides being pictures of the maximum and minimum moments, the diagrams show other interesting Fig. 357, is for the cantilever bridge at Taylorsville. Where the curves are below the zero line, re-enforcing steel is needed in the top of the girder; where it is above the line, steel is needed in the bottom of the girder. The diagram, therefore, shows that steel is needed both in the top and bottom of the girder for a portion of the length of the span of the simple girder. It is not difficult, while looking at the diagram, to visualize the stresses, and the shape of the structure necessary to meet them. It is also evident that the curve where the simple girders join the side walls of the outlet works (the abutments of the bridge) is for appearance only, and is not necessarily an addition to the strength of the bridge. Fig. 358 is the diagram for maximum conditions for Huffman. These girders have a constant depth, and the area of steel required in the bottom of the girder is in direct proportion to the ordinates of the diagram.

The vertical shear at any cross section of a girder is the algebraic sum of all the loads and reactions on either side of the section. Figures 357 and 358 are shear curves for the Taylorsville and Huffman bridges, and give both maximum and minimum shears. If the total shear at any cross section is divided by the area of the average section, the average shear per unit of area is secured. If this average vertical shear exceeds 40 pounds per square inch, reenforcing is added. Experience and experimental data show that beams or girders never fail because of their vertical shear, but rather the failure cracks are due to the resultant of a combination of the vertical shearing stress with the horizontal shear, acting in a diagonal direction. Therefore, when the reenforcing is added. it is either vertical or diagonal steel or both.

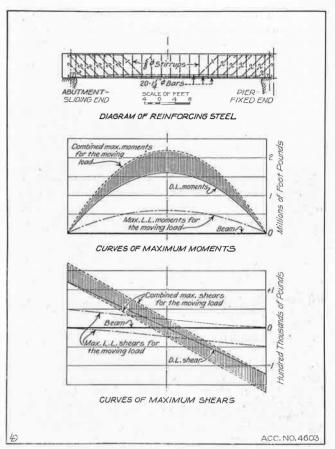
FIG. 358. THE SIMPLE GIRDER AT HUFFMAN. While much simpler than Fig. 357, the arrangement is the same.

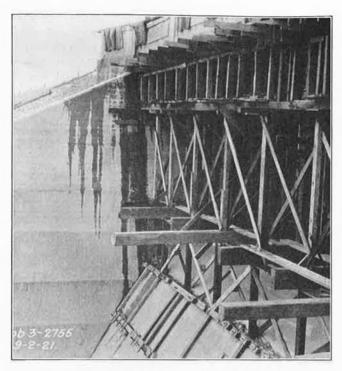
FIG. 359. BRIDGE FORMS AT LOCKINGTON, SEPTEMBER 2, 1921.

The bolts used to fasten the footing stringers to the curved face of the weirs are clearly shown. To further strengthen the footings a second row of bolts was placed lower down, and bracing put between.

horizontal steps. The forms for the entire structure were erected complete, except for the railings. The footings for the falsework were stringers fastened to the curved face of the weir by bolts previously cast in the weir. See Fig. 359. The concrete proportions were 1:2:4. The reinforcing was ovoid deformed bars, and was wired into position before concrete was poured. The gravel washing plants that were used in building the outlet structures were also used to prepare materials for the bridge work. The concrete was mixed and handled in bottom dump buckets. A steel derrick, mounted at Taylors-ville and Huffman on one of the berms of the dam, and at Lockington and Englewood, on the floor of

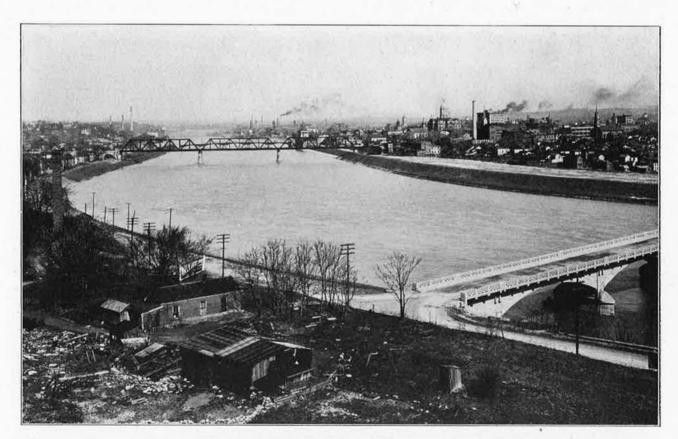
FIG. 362. THE HIGH WATER OF MARCH 15, 1922, AT HAMILTON.

A rainfall of two inches on March 14th, caused a storage of 36 feet in Germantown basin, 25 feet at Englewood, 15 feet at Lockington, 14 feet at Taylorsville, 11 feet at Huffman, and caused a 13 foot stage at Hamilton on the 15th. The operation of the improved channel is well illustrated. The view is looking upstream. The bridge in the lower right hand corner is the Columbia bridge. Then comes the steel railroad bridge, with the Main High Street bridge showing through the trusses. The new Black Street bridge can be dimly seen in the distance. The projection into the river between the Main High and Black Street structures is the river encroachment now being cleared away. Note the top of the concrete revetment just showing above the water.

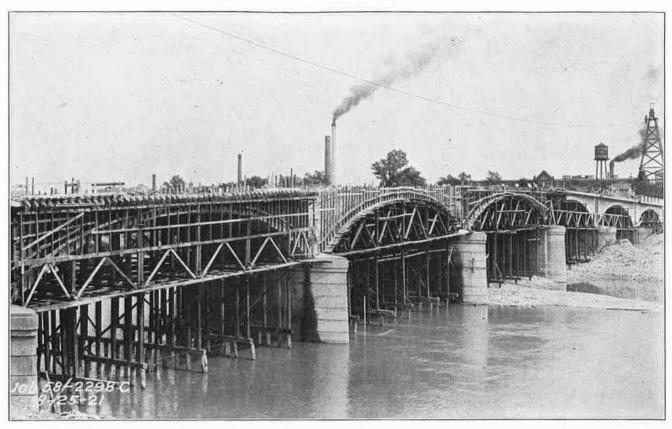
FIG. 364—BLACK STREET BRIDGE, HAMILTON, UNDER CONSTRUCTION AUGUST 8, 1921.

The arches are in various stages of completion. The one in the foreground has the full set of forms for the arch and spandrel walls in place. On the next two the forms are only partly in place. On the fourth and fifth only the skeleton frame work supporting the completed arch remains in place. On the last arch visible, the work is so far along that the posts for the railing are set. The form work is described elsewhere in this Bulletin. The wires overhead and the tower in the background are a part of the cableway used to transport materials and to handle forms.

The view is taken from the same position as Figure 364. The icicles on the under side of the arches mark the positions of the weep holes. The piling underneath has since been removed.

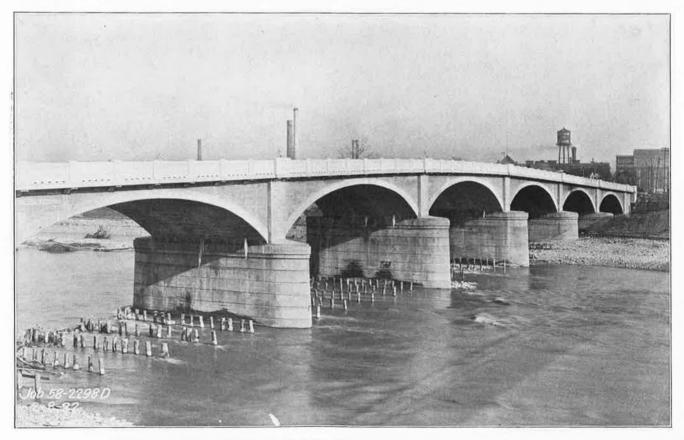
FIG. 365-THE FINISHED BLACK STREET BRIDGE, FEBRUARY 8, 1922.

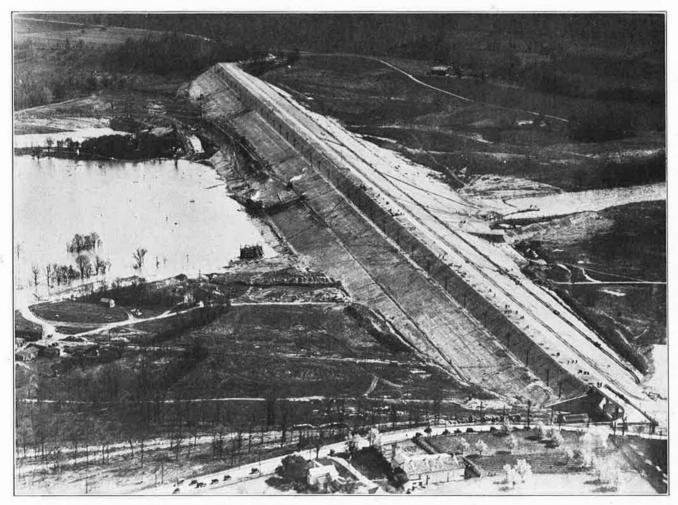
FIG. 366—THIRTY-SIX FEET OF WATER IN ENGLEWOOD BASIN, APRIL 15, 1922.

This picture was taken about the same time as Figure 363 with the aeroplane over the village of Englewood. The structure in the lower right hand corner is the spillway. The black object sticking up in the water close to the dam is the top of the gravel washer. The inlet to the conduits is just back of the gravel washer.

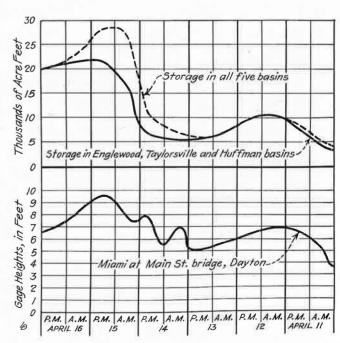
FIG. 368—DIAGRAM SHOWING BASIN STORAGE AND GAUGE HEIGHTS OF MIAMI AT DAYTON

ton, but not so heavy above the dams. The big rain of Friday started the main rise. The little hump just before midnight was caused by backwater from Wolf Creek's rampage, which was uncontrolled by retarding basins, plus the runoff from Dayton. As shown by the upper curves, the retarding basins were beginning to get to work, and consequently the curve of gauge heights in Dayton is a hump, rather than a peak. The smooth easy curve of the present day hydrograph is in marked contrast to the jagged peaks of the graphs of earlier days.

Everything went according to plan at the dams. During the rainy period preceding the 15th the water passed through them unimpeded. A small amount of storage shows on Figure 368 because the high stage caused a considerable depth of water in the conduits, and consequently some storage, but in general the inflow equalled the outflow. The rains of the 11th caused some additional storage at Englewood, but the storage dropped back on the 14th. The heavy rain of Friday evening caused a rapid increase in the storage in a relatively few hours on Saturday morning, which decreased in rapidity later in the day until the maximum was reached.

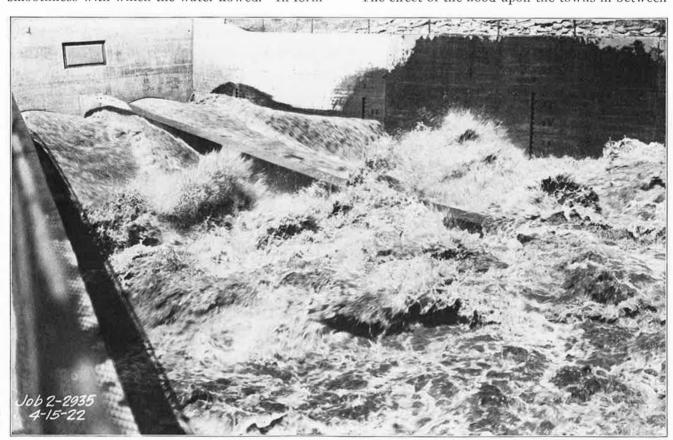
FIG. 369—THE ENGLEWOOD CONDUITS APRIL 15, 1922.

The picture gives only a meager idea of the tumult of the waters in the hydraulic jump. The wet places on the wall show how high the water leaped at times.

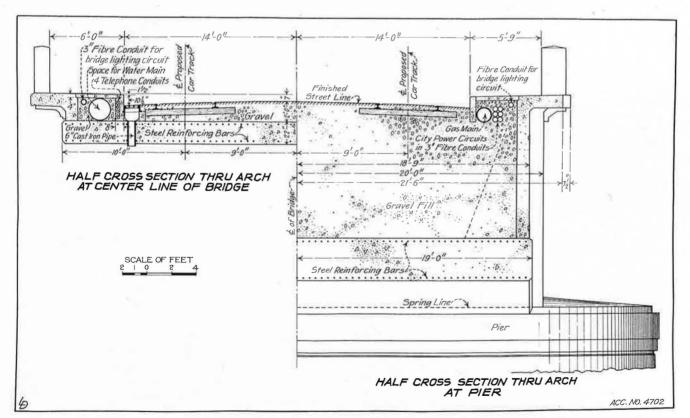
FIG. 372—DRAWING SHOWING SOME DETAILS AND DIMENSIONS OF THE BLACK STREET BRIDGE.

The tracks shown in the sketch will not be placed for the present. Extra steel in the arch is provided to carry the extra load of a street car. This can be seen in the section on the left.

Reference to Figure 372 will give the spacing and size of the reinforcing. The extra bars under the street car tracks should be noted. In placing the

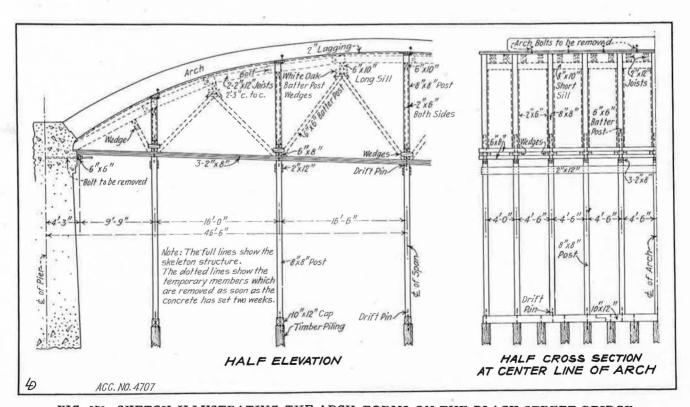
FIG. 373—SKETCH ILLUSTRATING THE ARCH FORMS ON THE BLACK STREET BRIDGE.

The sway-bracing has all been omitted on the drawing. The stringers in some cases were cut from a single piece; in others, the curved part was spiked to a straight stringer. Not all of the wedges were oak; some were good quality pine.

Naturally, the arch forms in such a bridge as this require a great deal of lumber. The posts and bracing have a good salvage value, but the lagging has little value save as kindling, when the bridge is finished. A substantial saving in the amount of lumber used was secured at Black Street by the use of a semi-removable falsework. First, a skeleton structure was built up on the pile foundation, as shown by the sketch in Figure 373. Five bents of 11 posts each were used under each arch.

These bents were placed on pile footings. At the level of the top of the piers a deck of longitudinal timbers was built, which helped brace the bents, and which also took the side thrust from the batter posts. A cap for each bent was run across the deck, both to carry the wedges for the vertical posts above, and to act as a heel for the batter posts. Then came the wedges, (to facilitate bringing the forms to the right level, and to make dismantling easy), then another cap, and then the eleven 8x8 vertical posts on each bent. This skeleton was thoroughly sway-braced. On top of the vertical posts was placed a strip of lagging, with bolts projecting upward that were gripped by the concrete after it was placed. This frame work composed the part of the falsework that remained in place throughout the work, and that carried the dead load until completion. It also afforded support for the forms for the spandrel walls and cantilever sidewalk. Full details are shown in Figure 373.

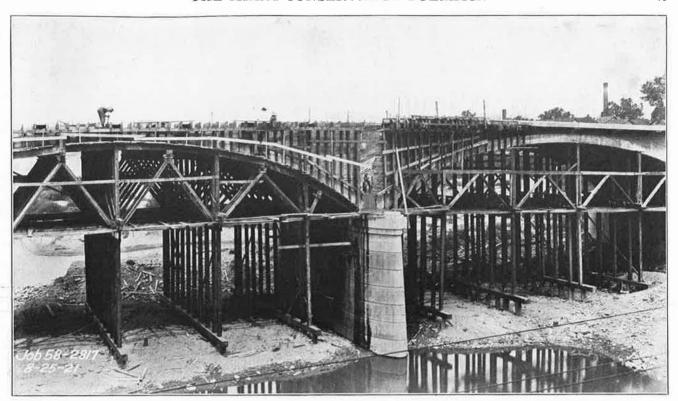
FIG. 374—BLACK STREET ARCH FORMS AS ACTUALLY BUILT, AUGUST 25, 1921. The arch on the left has the full forms under it. The one on the right has only the skeleton forms supporting it.

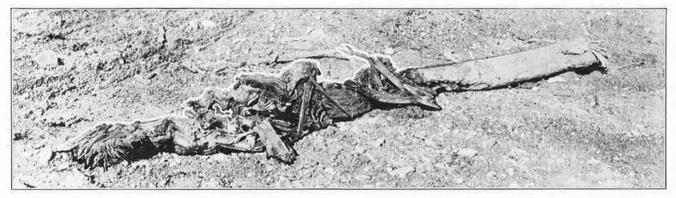
FIG. 375—RESULT OF AN UNSUCCESSFUL ATTEMPT TO DRIVE AN OAK PILE THROUGH COMPACT GRAVEL AT BLACK STREET BRIDGE.

the slow progress the railroad company agreed to the track shifting, and the work progressed again. When the oak pile was dug out in excavating for the abutment, the slow penetration was discovered to really be a pounding up of the pile, which is shown in Figure 375. The pile had hardly made a dent in the gravel.

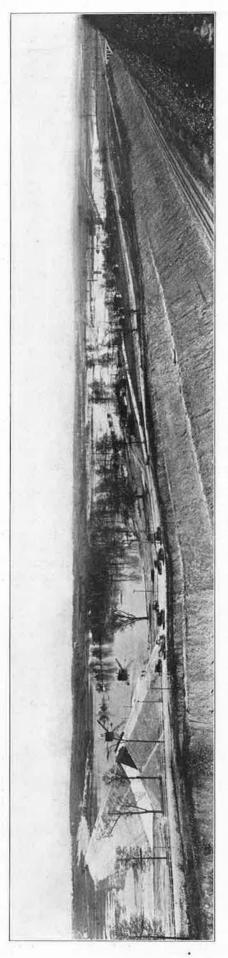
FIG. 377—PANORAMIC VIEW OF HUFFMAN BASIN ON APRIL 15, 1922.

The water in the basin was nearly 18 feet deep over the floor of the conduit tunnels. This was the first considerable storage that had occurred in this basin. The water was backed up over the lower end of the old Springfield Pike for the first time. The new location of the Springfield Pike

can be seen just below the edge of the railroad cut. It crosses the cut on the arch bridge seen at the extreme right of the picture. The railroad tracks in the right foreground are those of the Erie and Big Four. The Ohio Electric tracks are between the cut and the Springfield Pike.

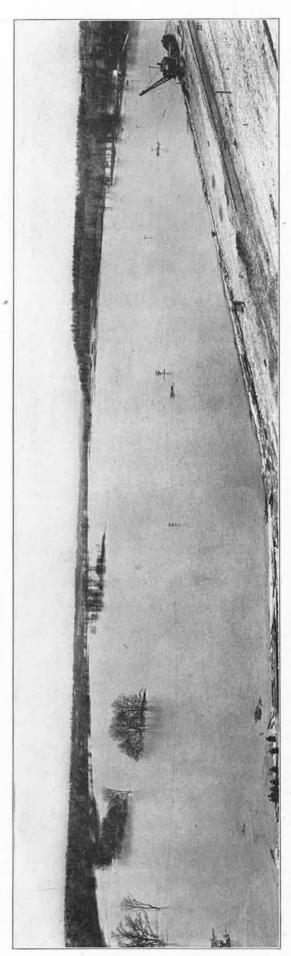
FIG. 378—VIEW LOOKING UPSTREAM FROM THE SIDE OF THE ENGLEWOOD DAM, APRIL 15, 1922

This shows conditions similar to those shown in the cover picture. The water is about 36 feet deep over the floor of the conduits. Nearly a foot more of storage was

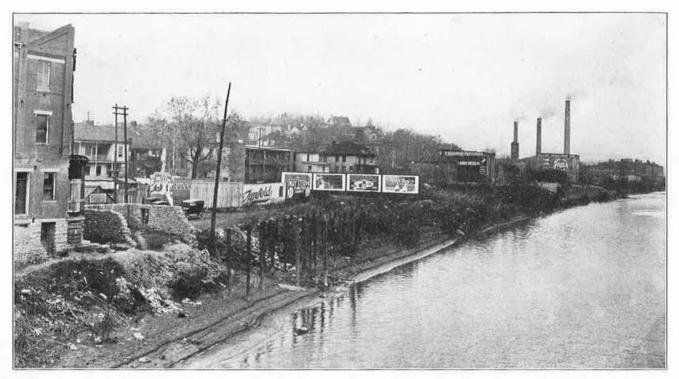
FIG. 380—THE WEST BANK OF THE MIAMI AT HAMILTON, LOOKING UPSTREAM FROM THE MAIN-HIGH BRIDGE, MARCH 1, 1918.

The three-story building and the old stone foundation shown in the left of the picture were in the way of the proposed levee, and obstructed the waterway of the Main-High bridge. The river bank above the foundation contained piling, old foundations, trash, projecting sewers, and was covered with a heavy growth of willows. The portion of the city to the west was subject to overflow from high river stages as there was no levee at this point. The river bank was unsightly, and was insanitary as well.

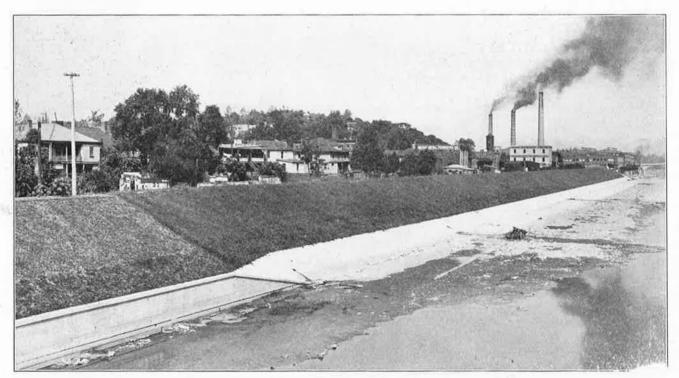
FIG. 381—THE WEST BANK OF THE MIAMI AT HAMILTON, LOOKING UPSTREAM FROM THE MAIN-HIGH BRIDGE, TAKEN SEPTEMBER 23, 1922.

This view shows the same territory as Fig. 380. The three-story building and the old foundation have been removed and the river widened somewhat. The river channel has also been deepened and cleared of bars along the shore. The piling, old foundations, trash and other obstructions have been taken out. A substantial earthen levee has been built to protect the west side of Hamilton. The wide white band along the base of the levee is the concrete revetment. At the foot of the revetment is a flexible mat made up of concrete blocks, woven together by galvanized cables. The portion of the levee above the revetment has been sown to grass, and good growth has resulted. The wall shown in the lower left hand corner is the beginning of the transition from the river section to the bridge opening. The clean banks and grassy slopes of the new levees have been a great civic improvement for Hamilton.

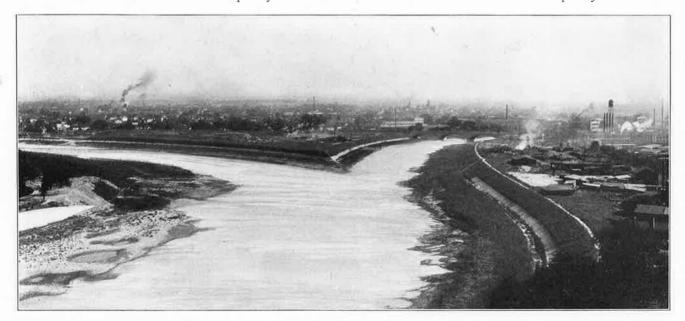
FIG. 382—LOOKING UPSTREAM AT THE JUNCTION OF THE MAD AND MIAMI RIVERS, DAYTON, SEPTEMBER 15, 1922.

The Mad is on the right, the Miami on the left. The bridge in the background is the one at Webster Street. The white streaks on the levees are revetments protecting the base of the levees against scour. Eventually the reclaimed land between the two rivers, and the open space in the right of the picture, will become city parks.

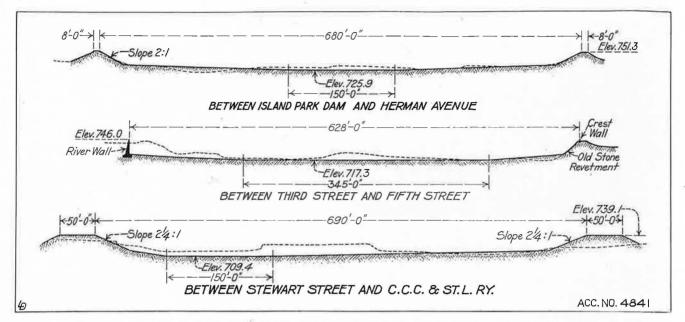
FIG. 383—THREE CROSS-SECTIONS OF THE RIVER CHANNEL THROUGH DAYTON.
The solid lines represent the improved waterway. The dotted lines show conditions as they were before the Conservancy work started.

channel. The new channel is designed, in conjunction with the retarding basins, to take care of a forty percent larger flood than that of 1913. If a flood that size should occur, the basins will let only enough water pass to produce a flow of 75,000 second feet in the Miami above Mad River, 110,000 second feet at Main Street, and 120,000 second feet below the mouth of Wolf Creek, and the water will only reach the freeboard line, three feet below the tops of the levees. A flood a great deal larger than forty percent greater than 1913 would have to occur before the levees would be overtopped. Figure 383 shows the dimensions of the channel at various points.

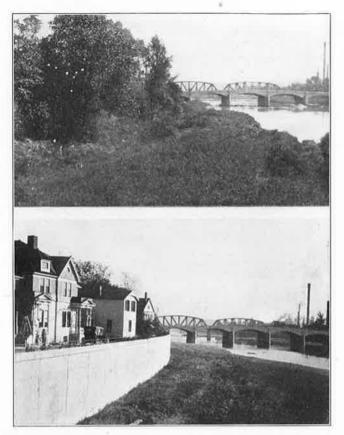
FIG. 385—BEFORE AND AFTER PICTURES OF THE LEFT BANK OF THE MIAMI RIVER BELOW THIRD STREET, DAYTON.

The views were taken looking downstream from the Third Street Bridge. The projecting point, covered with a tangled mass of vegetation, shown in the upper picture. is typical of a number of similar obstructions to the river flow that existed before the Conservancy work was started. flow that existed before the Conservancy work was started. The lower view shows the completed improvement. The high value of the real estate involved made it cheaper to build a wall than to buy enough right-of-way for a levee.

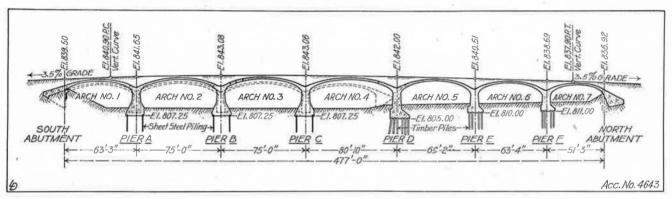
FIG. 387—ELEVATION OF THE RECONSTRUCTED ADAMS STREET BRIDGE, TROY.

The position of the old arches and the outline of the piers before they were enlarged, is shown by the dotted lines. The reconstructed bridge is shown by the solid lines. The enlargement of the old piers, and the protective sheet piling around them, should be especially noted.

The Adams Street Bridge reconstruction was more of a problem. The old bridge was built in 1913, and consisted of four reinforced concrete arches. See Figure 387. The outward appearance of the structure was good, but the pier footings were inadequate and some of the concrete was in bad condition. The footings were so narrow that they could not take care of the unbalanced forces from the new arches with a sufficient margin for safety. They were also set practically on top of the river bed, and were placed on a foundation supposed to be

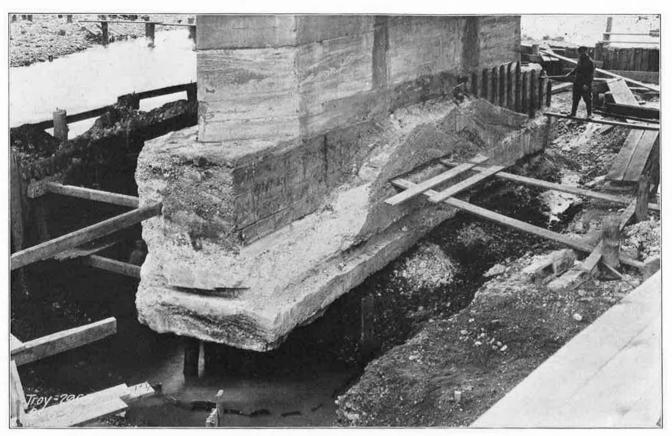
FIG. 389—A PIER OF THE ADAMS STREET BRIDGE READY FOR UNDERPINNING, FEBRUARY 6, 1922.

A coffer dam had been built, the gravel removed from around the pier, and the excavation made underneath the first third of the footing. The wooden piling underneath the old footing should be noted. The top of the line of protective sheet steel piling can be seen sticking out of the water in the bottom of the pit. Concrete was packed underneath the old footing, and the entire pier was encased in a jacket of concrete.

piles was disclosed. Sheet steel piling fifteen feet long was driven one foot inside of the line of the new footing and projecting up one foot into the footing. Concrete was packed into the space underneath the old footing, and around the old piles out past the line of the sheet piling. When the concrete was set, the next third was dug out, and the operation repeated. Figure 389 illustrates the procedure.

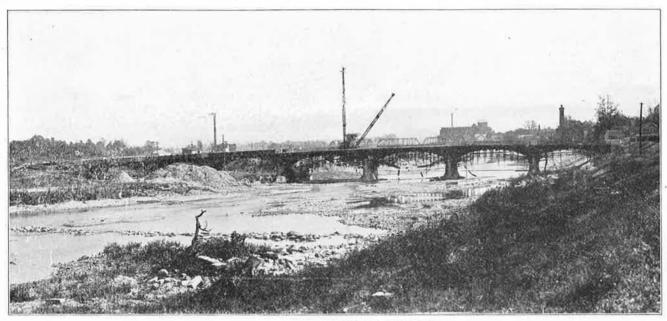
FIG. 392-ADAMS STREET BRIDGE, OCTOBER 14, 1922.

The old arches have been removed, but some of the old reinforcing steel with chunks of concrete clinging to it can be seen under the 3rd arch from the right. The rods hanging down from the underneath side of the new arches were used to carry the scaffolding that supported the wrecking crews. If the necessity had occurred the old arches would have been carried by these same rods during the wrecking process.

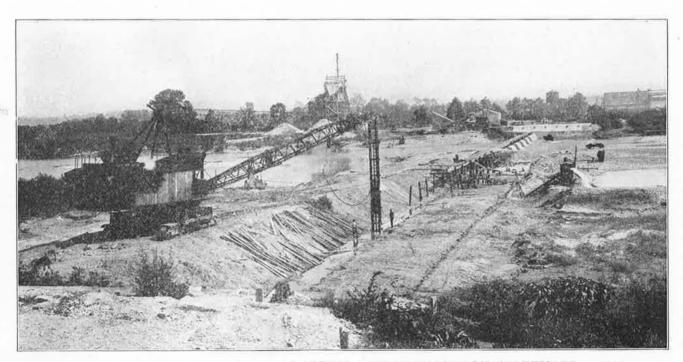
FIG. 393—GENERAL VIEW OF THE BARRIER DAM AT HAMILTON, SEPTEMBER 23, 1922.

The first section had been completed, and the river turned through the five gaps, when this view was taken. The coffer dam around the remainder of the dam had been built, and the water pumped out. The dragline in the foreground was engaged in driving piling, with the leads and hammer of the pile driver suspended from the end of the boom. The trestle carried the narrow gauge track used in the transportation of the concrete from the mixer to the forms.

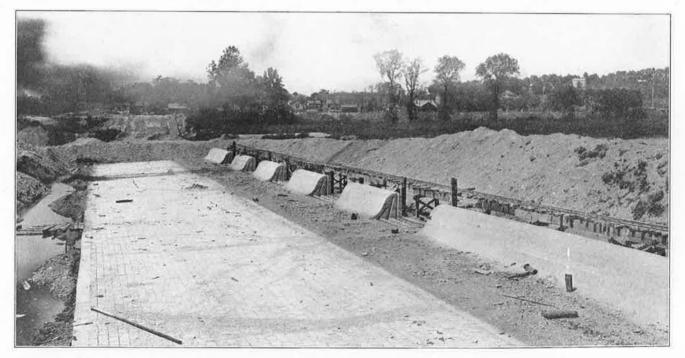
FIG. 395—THE FIRST SECTION OF THE BARRIER DAM AT HAMILTON, AUGUST 22, 1922.

The coffer dam was still in position. The five gaps in the spillway section were used to carry the river while the remainder of the dam was under construction. The trestle carried the track used in transporting concrete from the mixer to the forms.

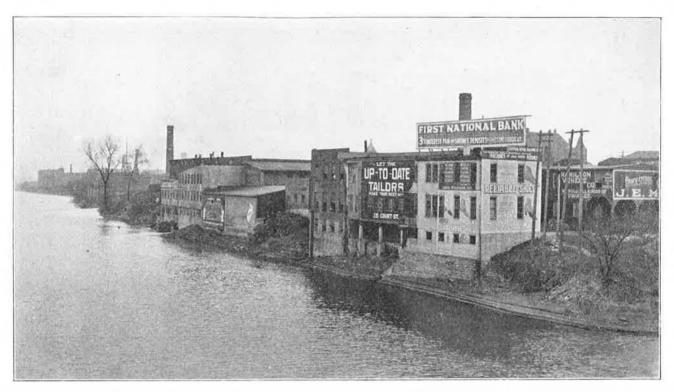
FIG. 397.—THE EAST BANK OF THE MIAMI AT HAMILTON NORTH OF MAIN ST. LOOKING UP-STREAM FROM MAIN-HIGH BRIDGE. APRIL 1, 1918.

Practically all of the buildings shown in this picture were removed in order that the river channel might be widened and that necessary space for the levee and walls be made.

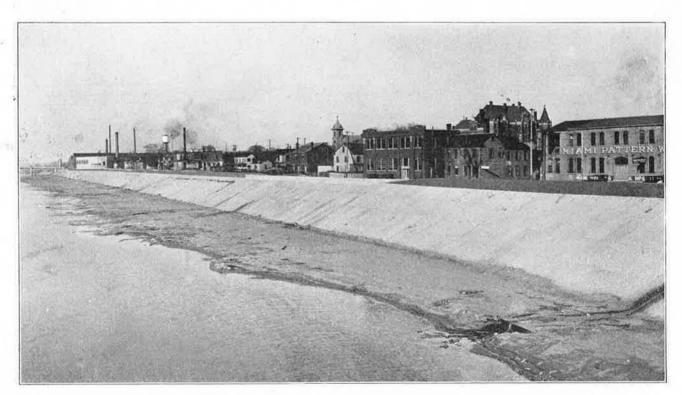
FIG. 398.—THE EAST BANK OF THE MIAMI AT HAMILTON NORTH OF MAIN ST. LOOKING UPSTREAM FROM MAIN-HIGH BRIDGE. APRIL 19, 1923.

This view shows the same section of river front as Fig. 397 above, after all construction work had been completed. The easterly end of the new Black St. bridge appears at the extreme left of the picture. The concrete revetment extends to within four feet of the top of the levee. Flexible block revetment was laid at the foot of the concrete on the slopes.

The condition of the channel before improvement was largely as the flood of 1913 had left it. The capacity within the banks was less than 100,000 second feet. Deep holes had been scoured in places and bars formed in others. The banks were irregular and overgrown with brush. The remains of three truss bridges were in the river below their respective sites and added to the obstructions. The channel had been encroached upon by manufacturers and residents along the banks by the erection of buildings and by the dumping of cinders and other waste. Figure 397 shows the condition of the east bank above the Main Street bridge before work was begun. Figure 398 is taken from the same point after the completion of the work.

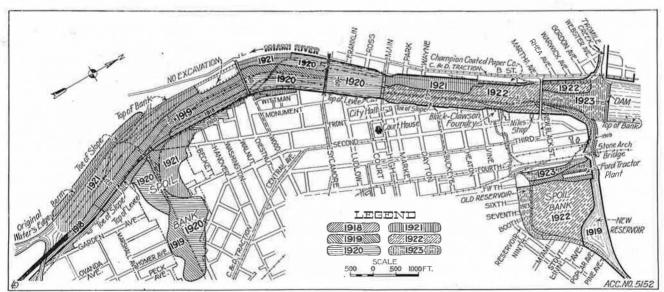
FIG. 399.—PLAT SHOWING THE EXTENT OF THE WORK AT HAMILTON.

The shaded portion indicates where the work was done and progress by seasons of the channel excavation and levee construction is shown. The total length of improved channel is about $2\frac{1}{2}$ miles. Levees or walls were constructed on the east bank of the river from the old river just below the dam to a point about 8500 feet below Columbia bridge.

Excavation was started at the lower end of the proposed improvement and progressed upstream. A small channel was first dug around Riley's Island to lower the water through the city thus facilitating the work. The excavation by years as well as the fill in spoil banks is shown on the map Fig. 399.

The track layout for the excavation is also shown in Figure 399. As the work south of Main Street bridge was being completed, tracks were being laid to the north spoil bank so that the hauling equipment was in readiness when the dragline started work north of Main Street. South of Main Street two trestles were required to make the material on the west side accessible. The decks of these trestles were cabled together and the cable anchored at one bank to prevent their being swept away by high water. North of Main Street bridge no trestles were necessary, most of the material on the west side being placed in the levee, and the remainder cast over to where it could be reached by the dragline from the east side. Revetment

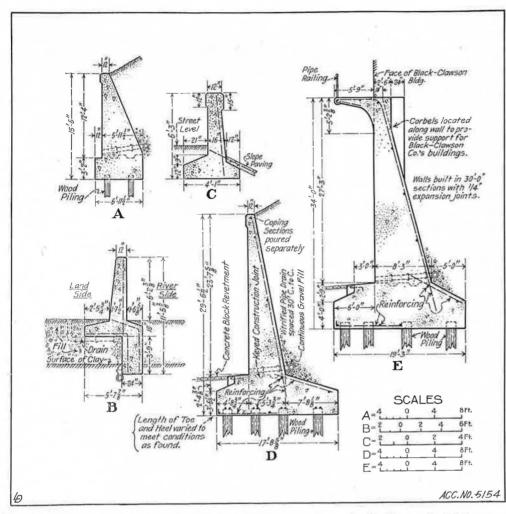
FIG. 400.—TYPICAL SECTIONS OF WALLS CONSTRUCTED AT HAMILTON.

Five types of wall were used. Type A is the usual type of retaining wall without steel reinforcing.

Five types of retaining walls were used. Figure 400-A is the plain gravity type which was used for retaining earth fills up to a height of 12 feet. Figure 400-B shows a type of wall used in place of a levee when space was limited. It is reinforced against water pressure and has a cut-off going down through the gravel to clay. No coping was used in this case as the wall is in a location where the additional expense for the sake of appearance was not warranted. Drains are provided under this wall to prevent upward pressure on the base. The third class of wall, Figure 400-C, was used along N. Monument Avenue where a levee would have taken up too much of the street. As it is in a conspicuous location and can be seen from both sides, a coping is provided on each side. The river side of this wall is connected by reinforcing to the slope revetment

which at this point reaches the base of the wall. The river walls at the Main Street bridge and the wing walls at the Black-Clawson foundry are of the type shown in Figure 400-D. This is known as the semi-reinforced type. The flexible block revetment is fastened to these walls by steel hooks spaced 1 foot apart and placed during the pouring of the wall. The Black-Clawson wall is shown in Figure 400-E. It is of the semi-reinforced type but differs from the other river walls in that it supports a cantilever side walk and carries the west wall of the Black-Clawson foundry buildings. During the construction of this wall the west portions of the buildings were removed and temporary wooden ends placed east of the excavation. After the completion of the work the west wall of the buildings was rebuilt of brick on top of the river wall.

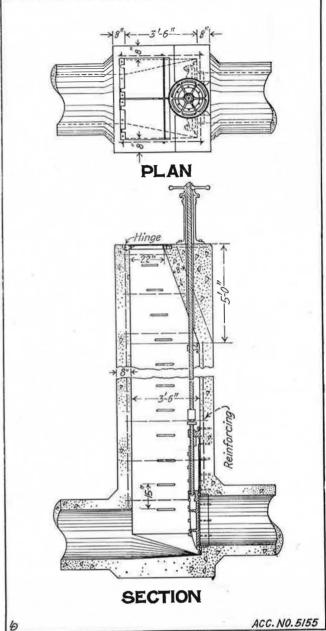
FIG. 401.—CROSS SECTION AND PLAN OF TYPI-CAL SLUICE GATE CHAMBER.

The gate is operated by turning the hand wheel at the top. enough to stay in place on a 2:1 slope. The proper mix for this purpose was a little too dry to run well in a chute.

A set of large sluice gates in the head-race of the American Writing Paper Company at Franklin is shown in Figure 404. A cross section of a typical gate chamber, such as were built on most of the larger sewers, is shown in Figure 401.

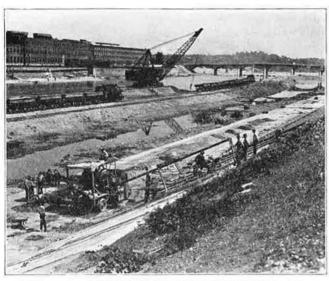
FIG. 402.—CONSTRUCTION ACTIVITIES AT HAMILTON.

In the foreground is the concrete mixer pouring slope revetment two slabs high, each slab being 13.5-fit, on the slope. In the center is a dragline loading cars. At the right is the Black St. bridge.

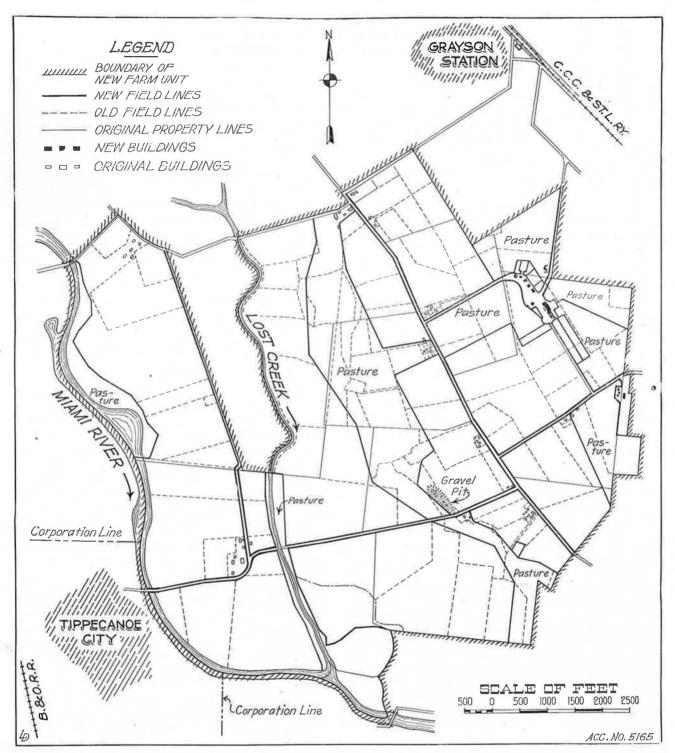
FIGURE 403.—MAP OF TRACT NORTHEAST OF TIPPECANOE CITY IN MIAMI COUNTY, KNOWN AS TAYLORSVILLE OPERATING UNIT NO. 1.

Figure 403 illustrates the necessity for the purchase by the District of much of the land which for the purpose of this article is called Class D. While this case is exceptional in that this new unit, or farm, is the largest in the whole project, it shows why it was not possible in many cases for the individual farm owners to sell flood easements and retain their farms.

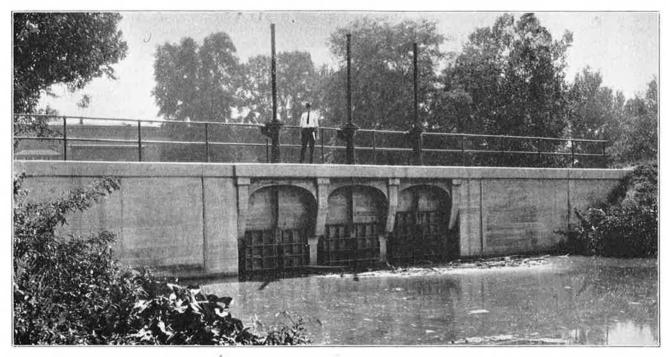
FIG. 404.—FLOOD GATES AT FRANKLIN.

These gates are in the head race of The American Writing Paper Co. They are each 6-ft. by 7-ft. The gate structure is in the line of the levee and is built into the levee at each end.

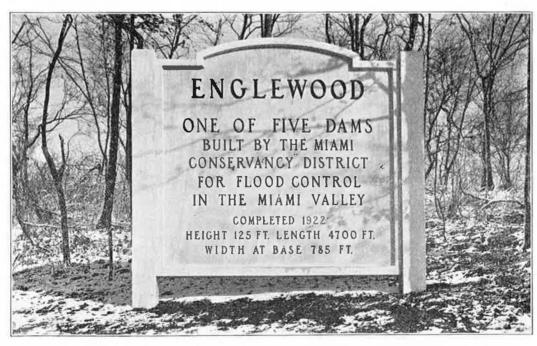
FIG. 405.—CONCRETE TABLET AT ENGLEWOOD DAM.

A similar tablet has been erected at each of the dams in a place easily seen by those who pass along the roads.
